Motorcycle Oil Leak:

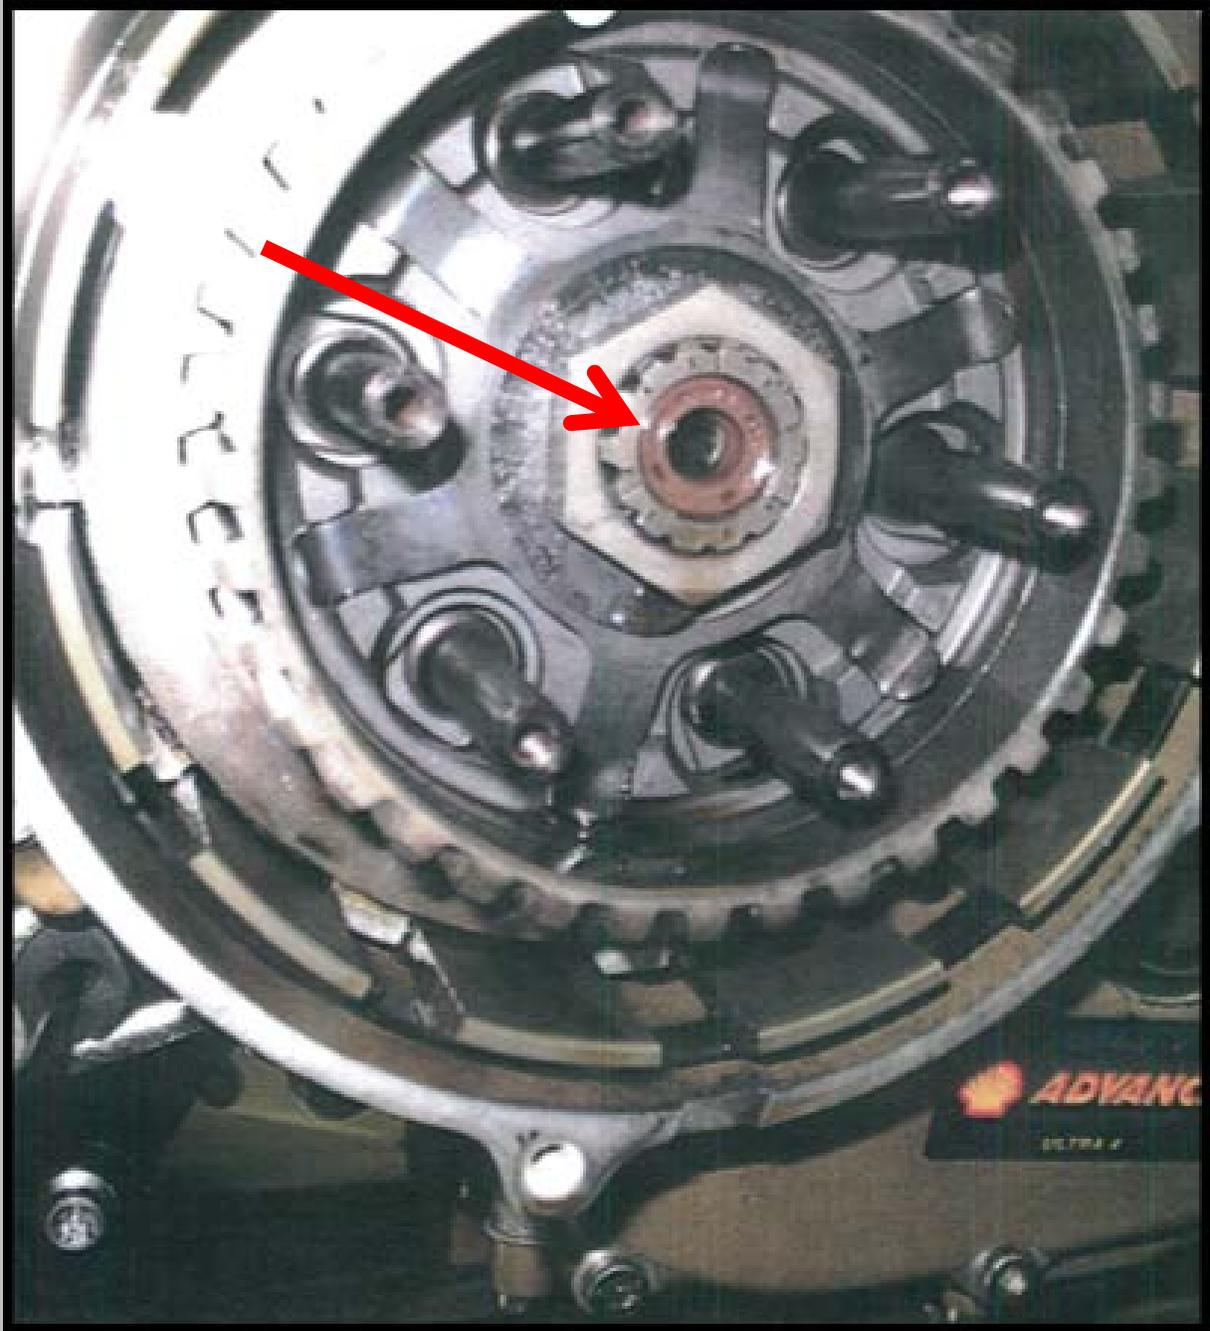
A motorcycle enthusiast purchased a high-end Italian racing replica. While riding through the countryside, he cornered to the right. The rear tire lost traction and then rapidly re-established its grip, flipping the rider over to the left with a "high side" overturn. He suffered a fractured wrist and other injuries. He righted his bike and found that oil had covered the underside of the belly fairing and the rear tire. At the dealer, when running the motorcycle on a test stand, oil poured out past a seal that surrounded the clutch rod at the bottom right of the bike.

This photo of the clutch cavity shows the failed seal called out with a red arrow and the leaking synthetic oil. Note that the failed seal looks very much like a conventional plumbing washer. The housing, clutch push rod, friction and steel clutch discs, pressure pad and other components have been removed.

The manufacturer disputed that oil bleeding past the seal caused the accident. They attributed the damage to the wreck that they say was caused by operator error. However, discovery showed that the seal had been manufactured out of its design tolerance, and that numerous other customers had suffered the same defect and required warranty repair, although no other wrecks were attributable to the seal defect. Importantly, the accident bike impacted on its left side, while the seal and leak were on the right side. All other damage to the motorcycle was cosmetic; after the seal was replaced, the motorcycle worked as designed without leaking oil.

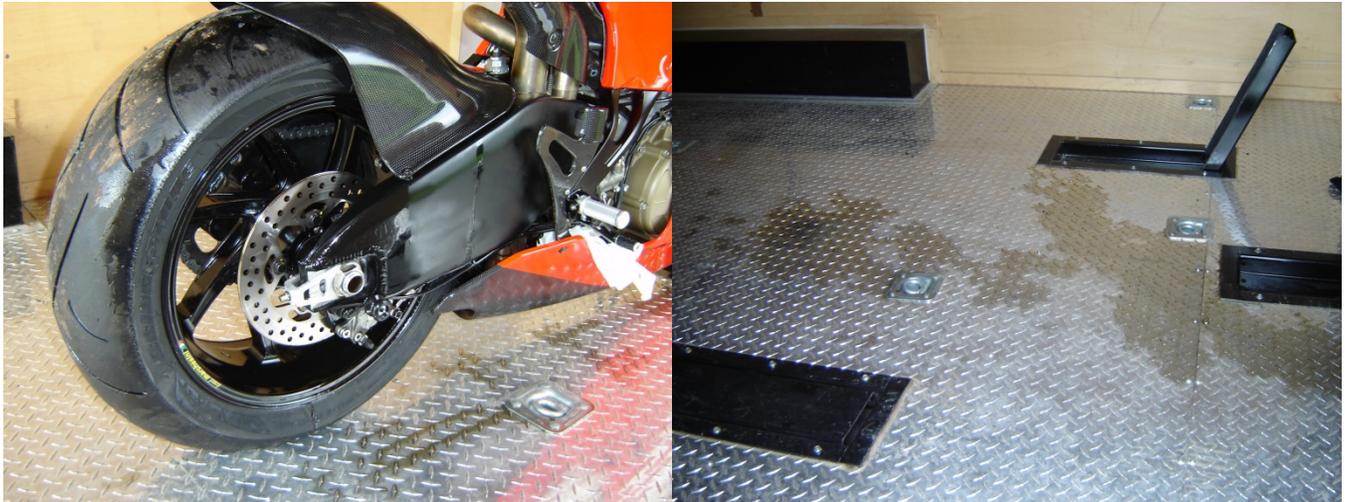
Motorcycle directly after accident in the motorcycle trailer (left). After the motorcycle was removed, synthetic oil was left on the diamond plate floor (right).
