### Auger Drill Accident:

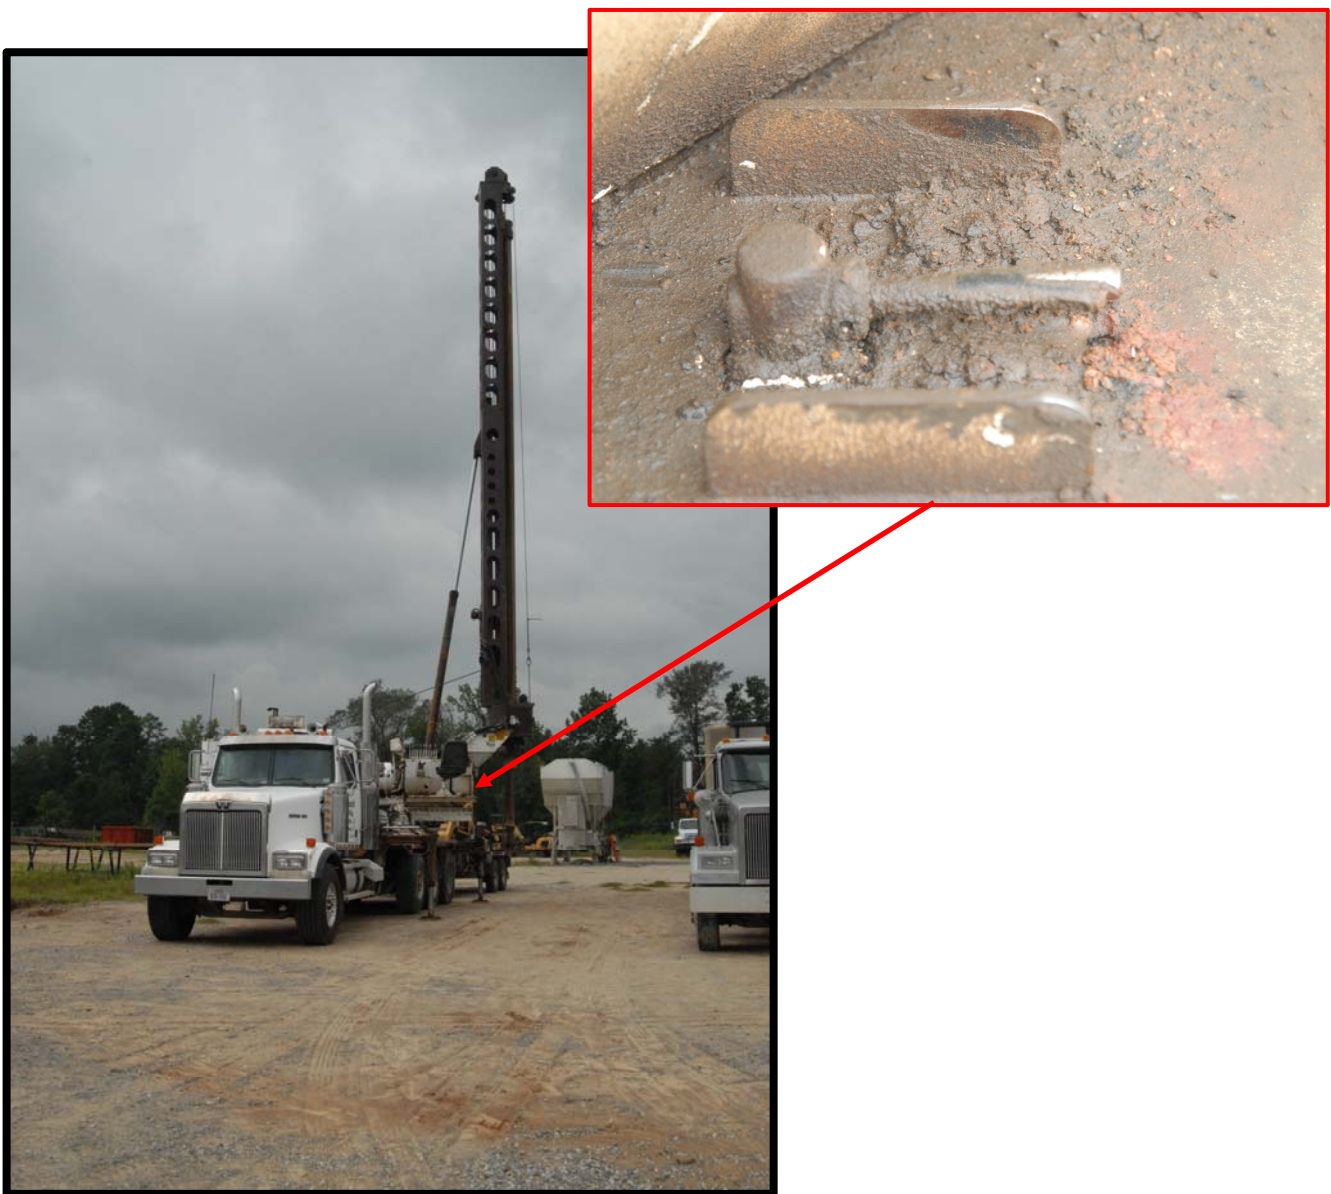
An exposed foot switch led to a preventable serious accident in Louisiana. The design of a truck-based auger drilling platform had the operator seated such that he did not directly face the six foot diameter drill bit, but rather at an approximate 90° angle. Further, the drill's free fall switch was mounted on the platform where the operator rested his feet and was unguarded. By resting his left foot on the platform, the operator would periodically, and accidentally, release the drill, which weighed hundreds of pounds. The drill descended both rapidly and silently. The ensuing accident was entirely predictable. At a job site, the ground man told the operator to "hold up" and went underneath the drill to retrieve the T-post that acted as a location marker. The drill operator looked away and unknowingly actuated the free fall switch when he repositioned his left foot. The ground man was crushed by the drill, but fortunately not killed. I determined that the switch was defective as it was unprotected, out of sight, and unnecessary to the operation of the device; it was a convenience only. An unguarded switch that actually encourages life-altering injuries does not follow standard and customary design practices.
