CNC Lathe Window Guard Failure Analysis:

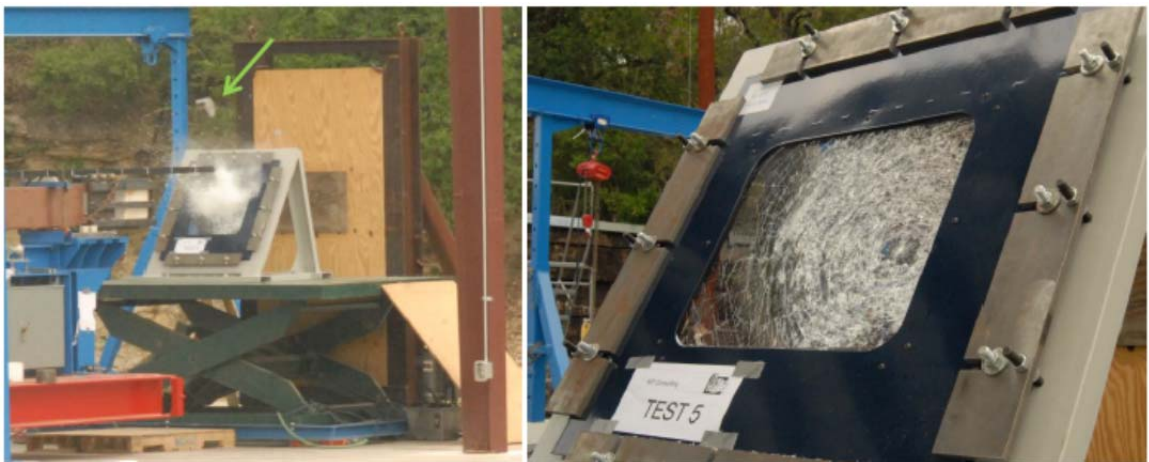
Images from lathe window test. Top – Pneumatic gun for launching workpieces. Lower Left – tested window with rebounding workpiece. Lower Right – Condition of window post Test 5.
